# Bathymetric Surveys at Highway Bridges Crossing the Missouri and Mississippi Rivers near St. Louis, Missouri, 2010

Scientific Investigations Report 2011–5170

By Richard J. Huizinga

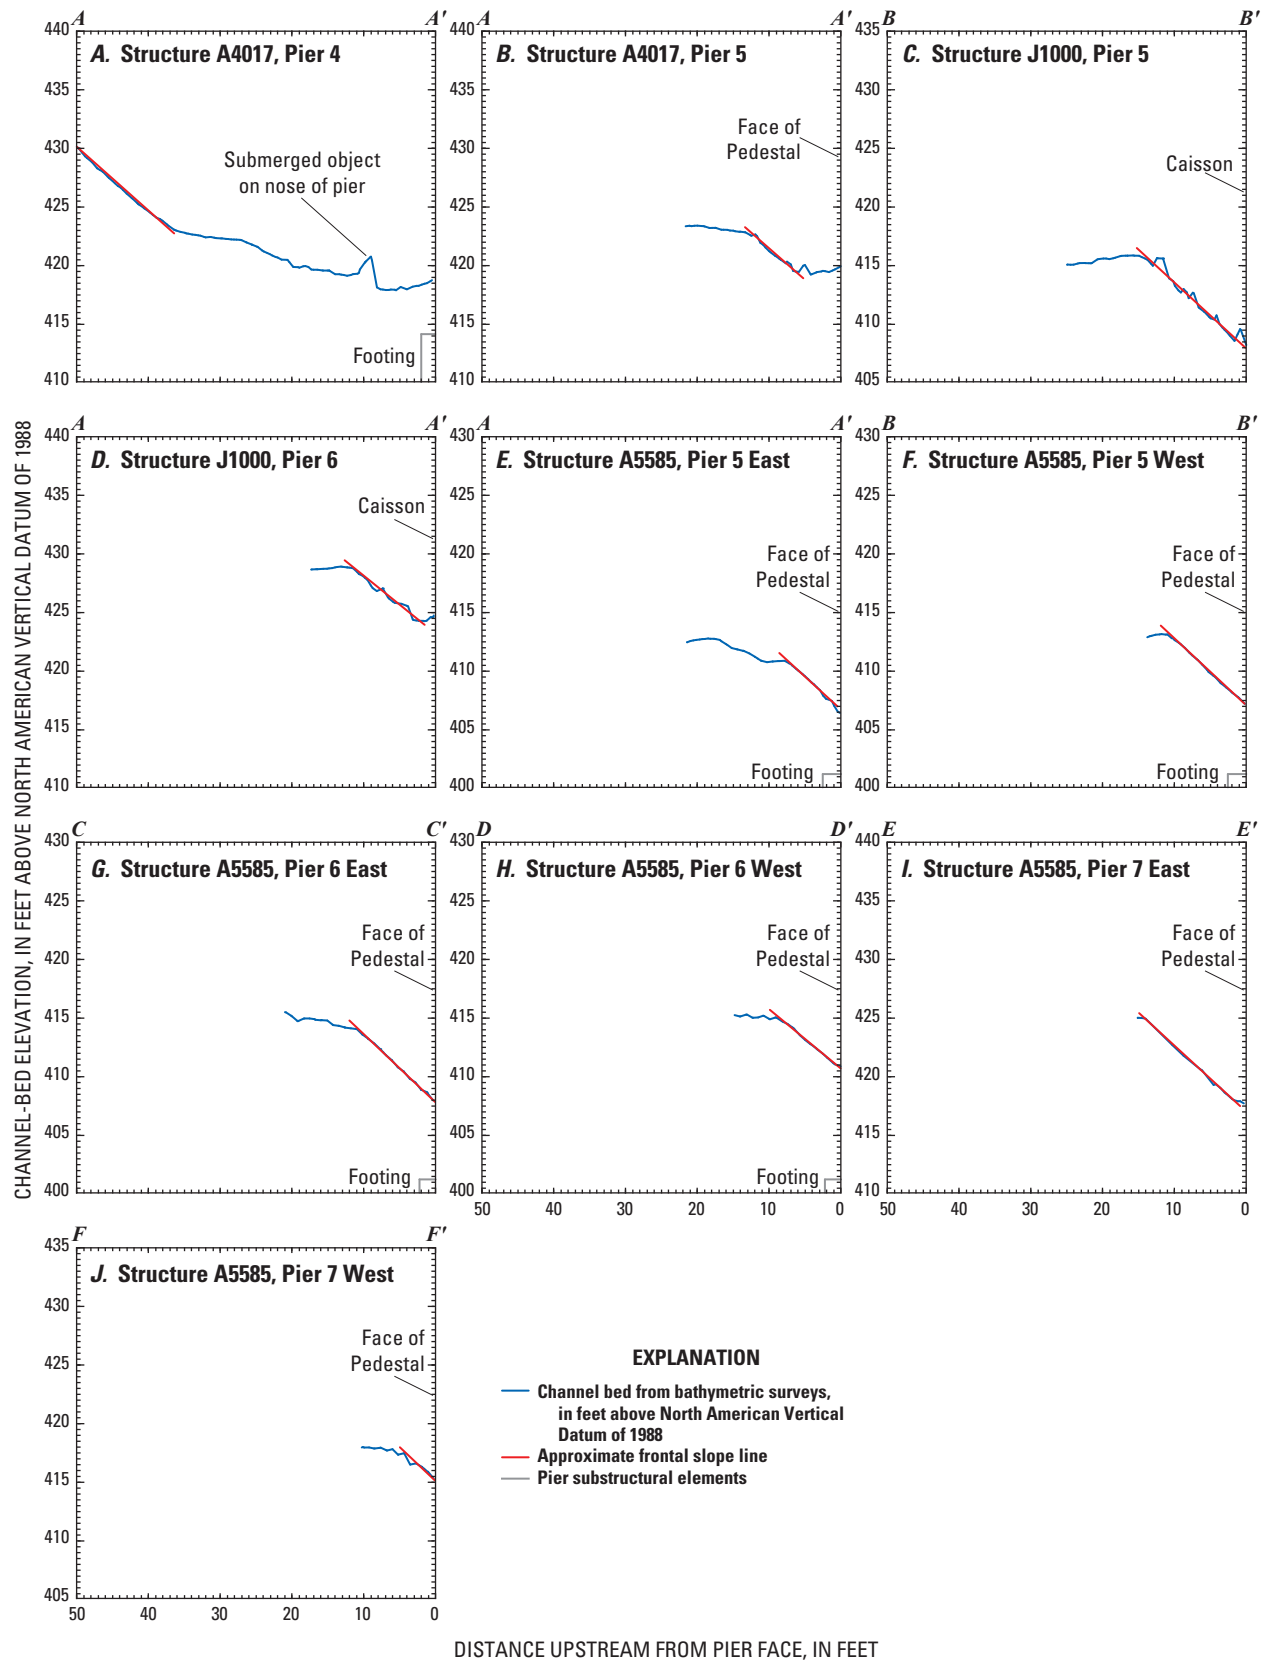
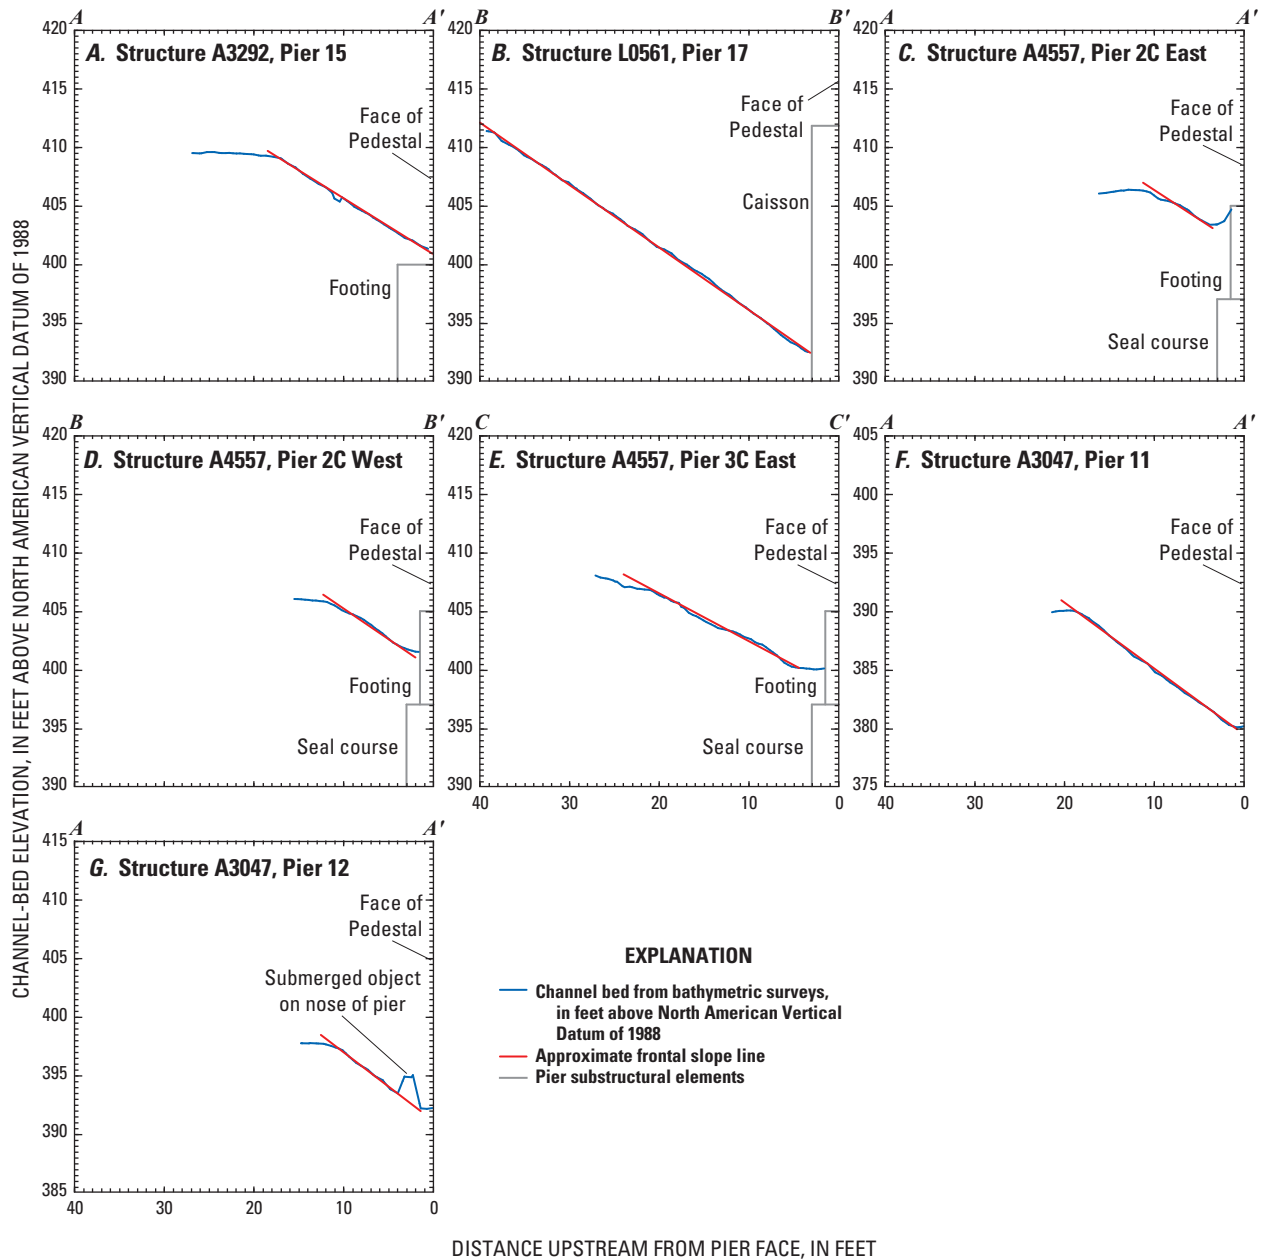
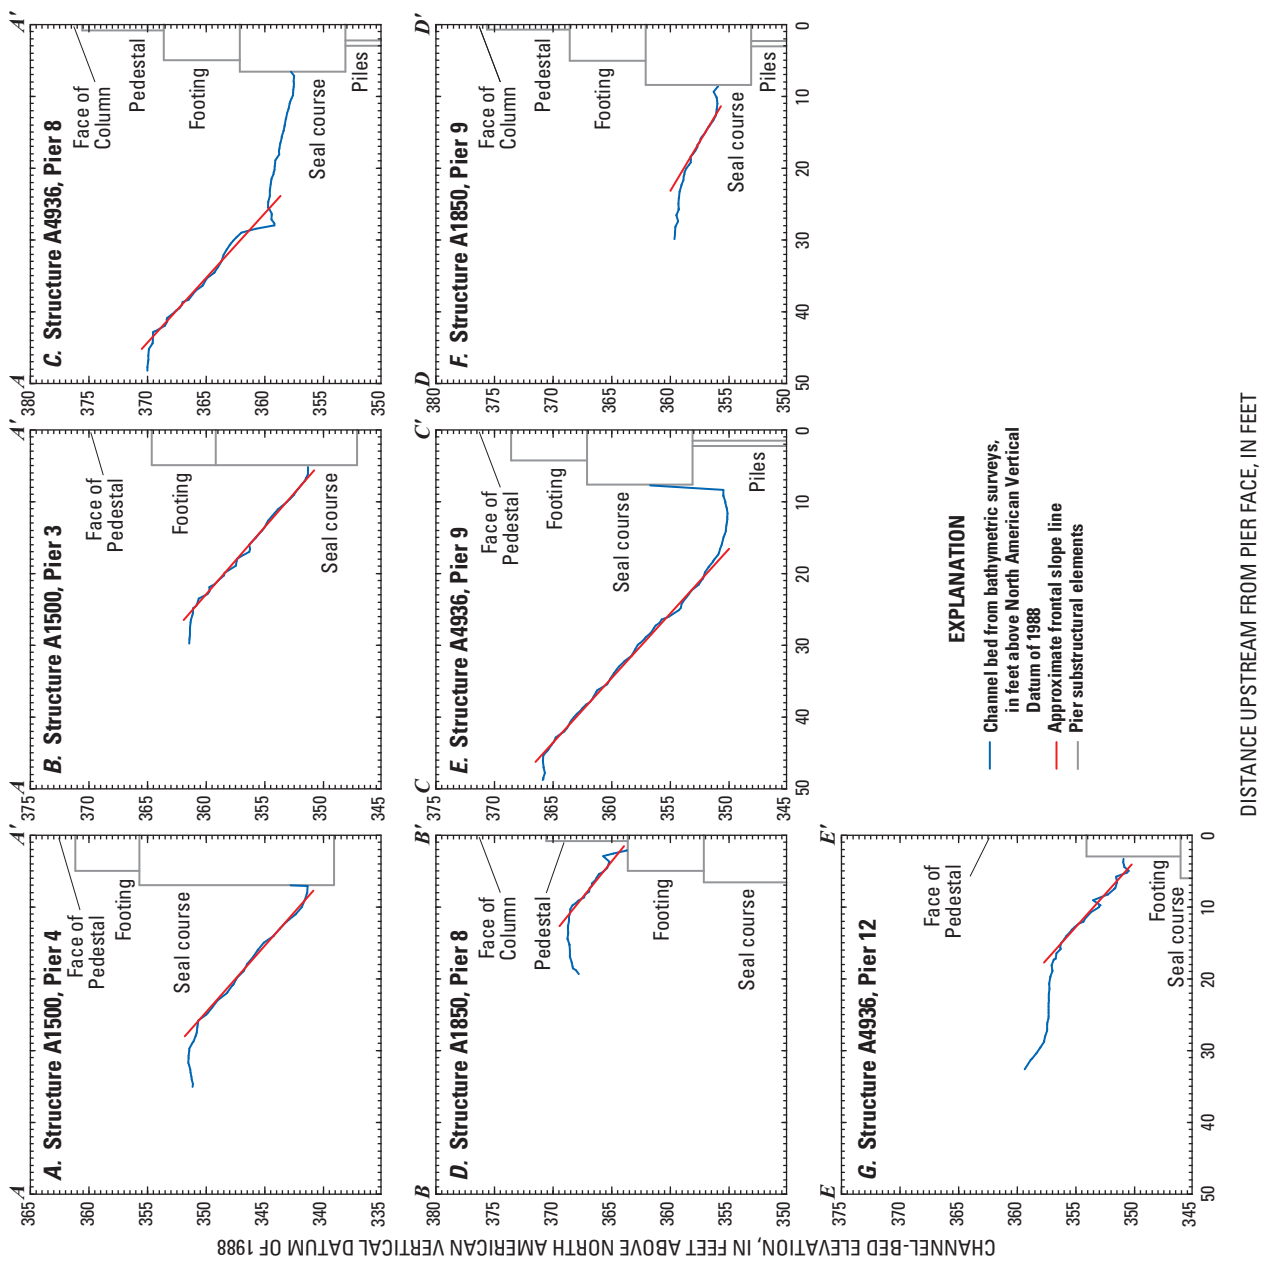
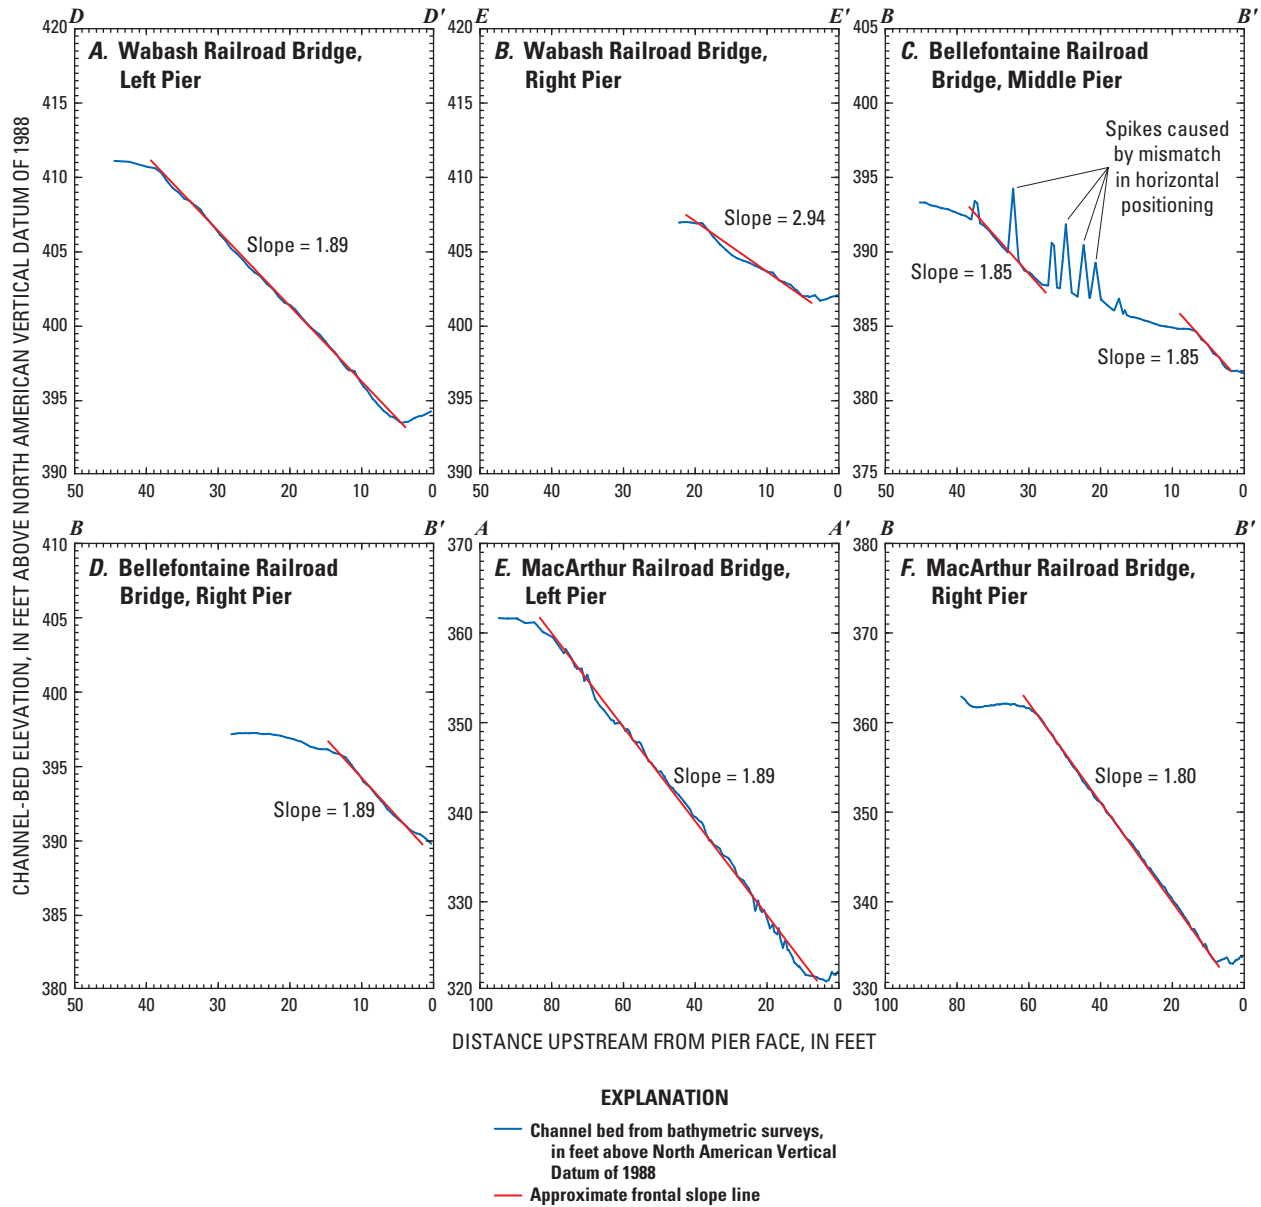
Generally, every pier in the main channel area for which bathymetry could be obtained had some sort of scour hole, except those on banks or embedded in rock dikes. A longitudinal profile was drawn upstream from the nose of each pier with a well-defined scour hole (figs. 50–53), and the approximate frontal slope (computed as horizontal distance over vertical distance, or run over rise) was determined for each hole (tables 6, 7). The frontal slope was not determined for piers with poorly defined scour holes; however, the frontal slope was determined for scour holes near the various railroad bridge piers surveyed, because they often were more well-defined and deeper than the scour holes at the nearby MoDOT structure (fig. 53).

The approximate frontal slope (defined herein as run over rise for relatability to highway embankment slopes) of the well-defined scour holes ranged from 1.70 to 2.94 (fig. 53; tables 6, 7); however, the holes with the largest slope values—or the shallowest slopes—[2.42 at structure A4557 Eastbound pier 3C (figs. 24, 51E; table 6), 2.72 at structure A1850 pier 9 (figs. 43, 52F; table 7), and 2.94 at the Wabash Railroad Bridge right pier (figs. 24, 53B)] are in lower velocity areas of the channel and may be affected by submerged objects in or near the scour hole. Submerged objects and rafts can cause the scour hole to enlarge by creating a wider obstruction to the flow, such as at structure A3292 pier 15 (fig. 18), and is believed to be part of the cause of the wide, shallow scour hole observed at structure A4017 pier 4 (figs. 6, 50A). If the three shallow slope values are not included, the frontal slopes ranged from 1.70 to 2.05, with a mean value of 1.85. Richardson and Davis (2001) noted that the side slope of a scour hole in cohesionless sand in air could range from 1.0 to 1.8 depending on the composition of the bed material and its dry angle of repose, and suggest using a value of 2.0 for design purposes to account for the wet angle of repose. The slope values determined in the St. Louis area generally are similar to the values noted in Richardson and Davis (2001). In the previous study in the Kansas City area, Huizinga (2010) stated “the slope values determined in the Kansas City area [(ranging from 1.77 to 2.49)] are somewhat greater than the range of values noted in Richardson and Davis (2001),” without making the distinction between the dry and wet angle of repose of cohesionless sand. When the wet angle of repose is considered, the slope values determined for scour holes in the Kansas City area are similar to those noted in Richardson and Davis (2001), as well

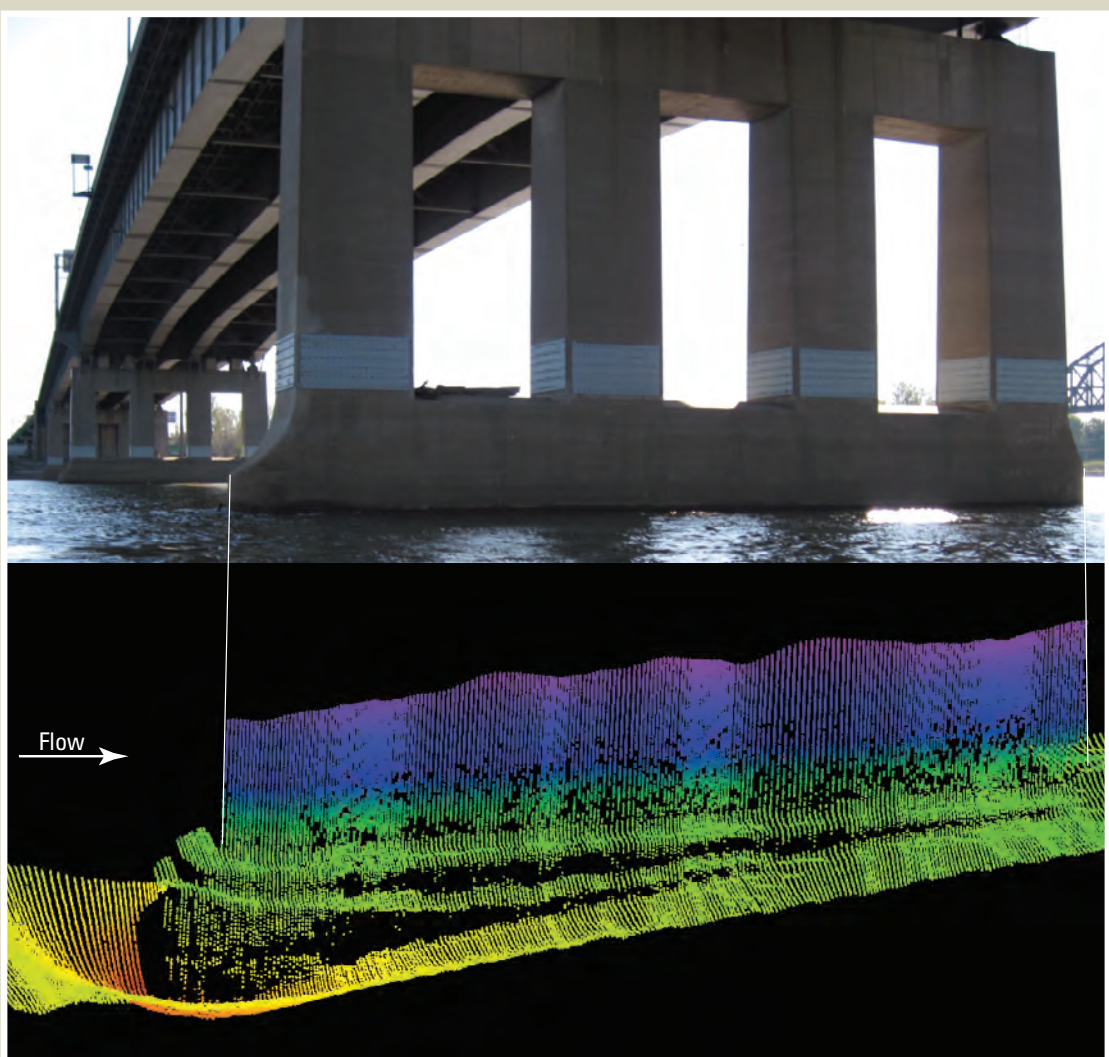
**Back cover.** Point cloud visualization of the channel bed and right (west) side of the left main channel pier (pier 4) of structure A1500 on Interstate 55 over the Mississippi River near St. Louis, Missouri.
